Conservatory awnings – shade for large areas

markilux pergola 110 / 210

This booklet describes in simple words the necessary assembly steps in case any problems occur.

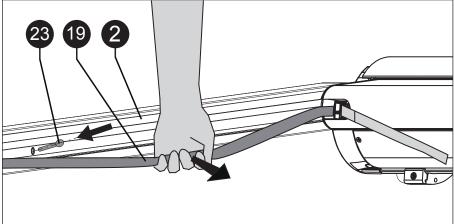
Possibility A: Retracted or partially retracted awning.

By pulling the drive belt (19) out of the guide rail (2) in the direction of the middle of the awning, release the tension on the clamping module and fix it using a safety splint (23) into the guide rail (right and left).

NOTE: If the cloth should be reclamped, pull out the safety splint (23) by releasing the tension on the clamping module again, see also Chapter 3, Point 4.

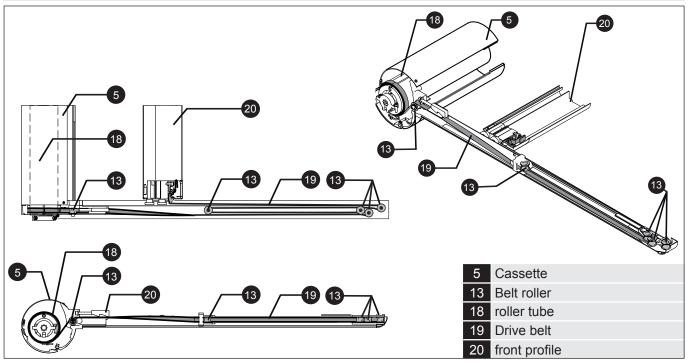
3. ... if the drive belt in the guide rail is twisted?

1. Release the tension on the awning cloth as described in Chapter 2 by fixing the clamping module with the safety splint (23) (right and left). Open the inspection cap (see Chapter 1). Remove the cap closure (21) of the projection profile, remove the drive belt (19).

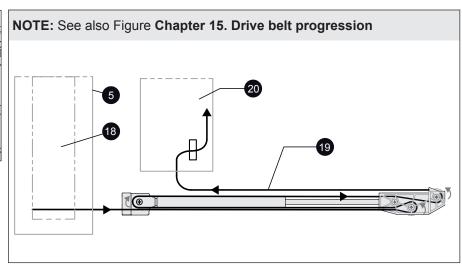
4. By pulling the drive belt (19) in the guide rail (2) in the direction of the middle of the awning, release the tension on the inside clamping module so that the splint (23) can be pulled out easily (right and left). The awning is now under tension.

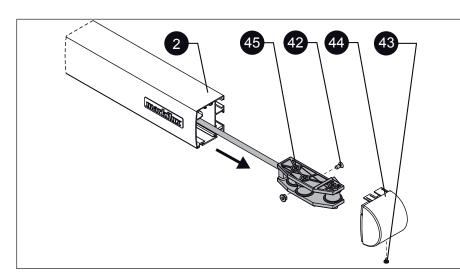
- **1. Retract the connected** Velcro fastener (22) with the drive belt (19) through the belt clamp (29) of the projection profile.
- 2. Remove the guide rail cover (44) by loosening the fillister head self-tapping screw (43) and removing the clamping module (38) from the guide rail (2). To do this, unscrew the countersunk screw M 5 (42) at the side of the holder for the gas pressure spring (45).
- **3.** Retract the available drive belt (19) back into the guide rail again and thread into the clamping module. Ensure central position and no twisting of the drive belts (19) on the deflection rollers.
- **4.** Install a new clamping module into the guide rail.

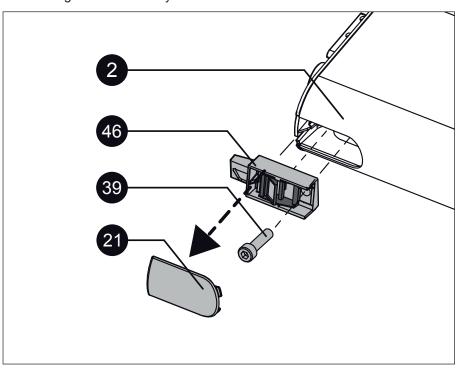
11. ... the Velcro fastener / drive belt has been pulled out of the belt clamp in the projection profile?

- 1. Remove the cap closure (21).
- 2. Remove the belt clamp with the belt clamp holder (46). To do this, loosen the socket head cap screw with hexagon socket, key width 6 (39).
- 3. Grip the drive belt and the Velcro fastener and carefully thread it through the projection profile (2) and through the dismantled belt clamp holder (46).

Note: Should the Velcro fastener be damaged or torn off, then thread the end of the drive belt (without the Velcro fastener) directly through the belt clamp holder (46). If necessary, the Velcro fastener can also be retightened with staples.

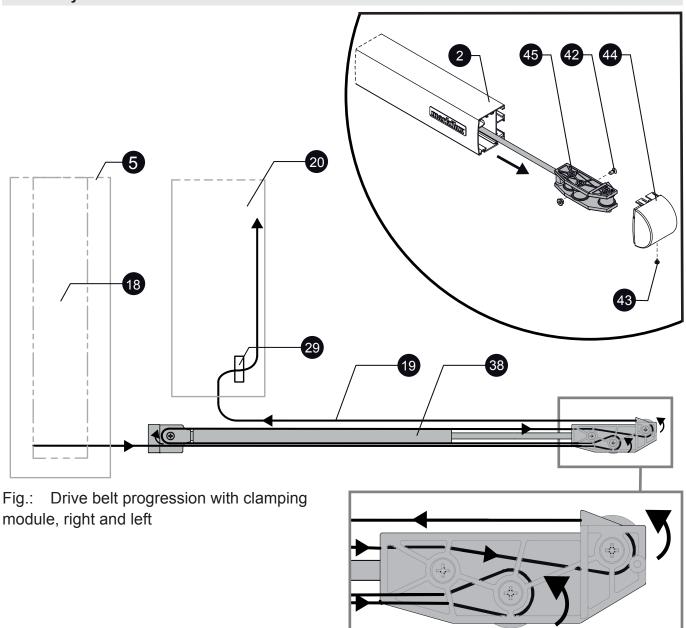
Possibility A: The drive belt is torn

- **1.** If the drive belt is torn, the appropriate clamping module is relieved of tension. The second drive belt must then also be relieved of tension according to Chapter 2. Possibility B, by pressing the belt clamp.
- 2. On the side where the drive belt has to be replaced:

Remove the guide rail cover (44) by loosening the fillister head self-tapping screw (43) and removing the clamping module (38) from the guide rail (2). To do this, unscrew the countersunk screw M 5 (42) at the side of the holder for the gas pressure spring (45).
- 3. Remove the old drive belt (19).
- **4.** Thread the new drive belt (19) onto the clamping module and then into the guide rail (38). Ensure central position and correct running of the drive belts (19) on the deflection rollers.
- 5. Reinstall the belt clamp (29) after pulling through the drive belt (19) (see Chapter 11).
- **6.** Fasten the drive belt clamping loop onto the roller tube, see Chapter 4.
- 7. Reclamp the awning, see also Chapter 3, from Point 3.

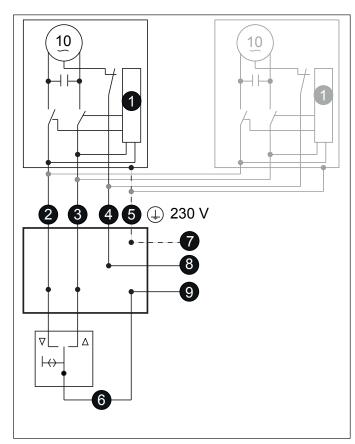
C Plug-in coupling wiring diagram "Hirschmann" for "Becker" standard motor without radio.

Becker drives with electronic limit switching can be switched in parallel.

1	Electronics
2	black
3	brown
4	blue
5	green-yellow
6	Adjustment set
7	Protective conductor (green-yellow)
8	N (Neutral conductor, blue)
9	L1 (Phase, brown or black)
10	motor

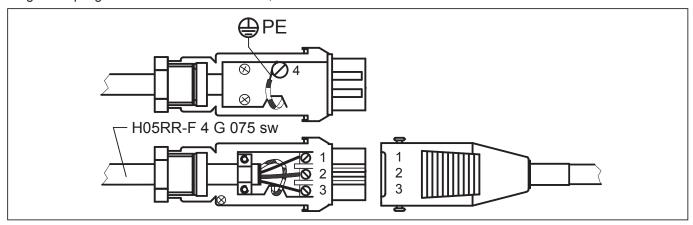
Plug-in coupling for "Becker" standard motor, connection line 4 x 1.5 mm²

Neutral (blue)High/low command (black)

3 High/low command (brown)
